Manhole Inspection Summary

Manhole # S13KK1004MH

Location Address: **4507 PIMILICO RD**

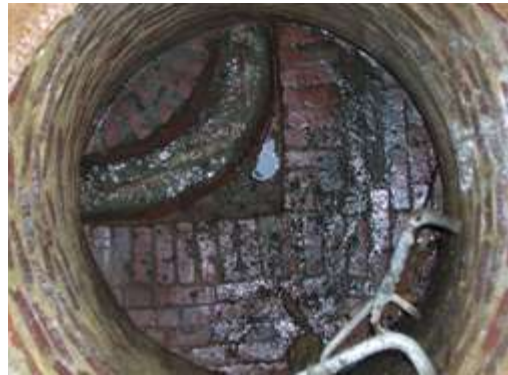
Top View

Bench debris. Corroded step.

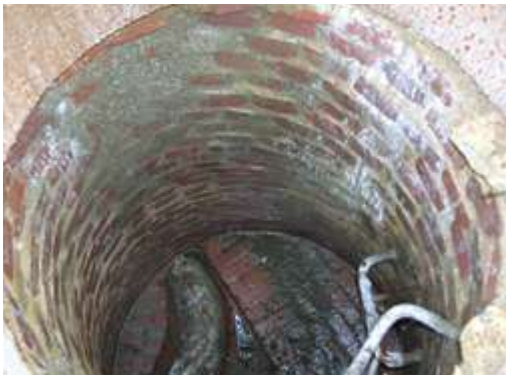
Defect

Frame offset. Adjustment deterioration, loose brick, root intrusion and infiltration. Corbel infiltration.

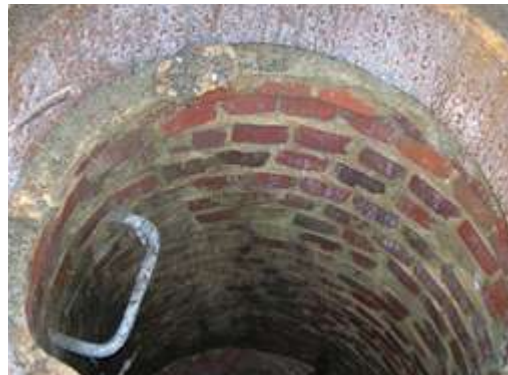
Defect

Frame offset. Adjustment deterioration, loose brick, root intrusion and infiltration. Corbel infiltration - other side.

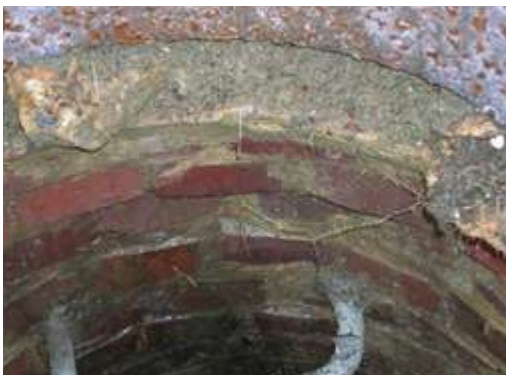
Defect

Frame offset. Adjustment deterioration, loose brick, root intrusion and infiltration. Corbel infiltration.

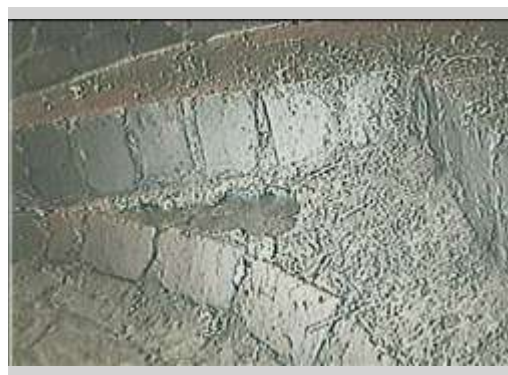
Defect

Channel deterioration.

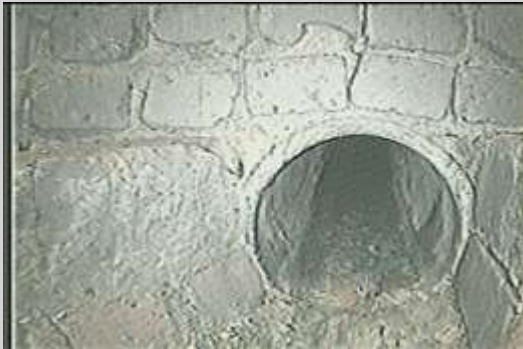
8 in. Circular Gravity Sewer Pipe Out @ 12 O'Clock

Deposits: ☐ None ☐ Mud ☐ Sludge ☐ Debris ☒ Grease

Silt Depth: **0** (in.) Deposits Extent: **Light**

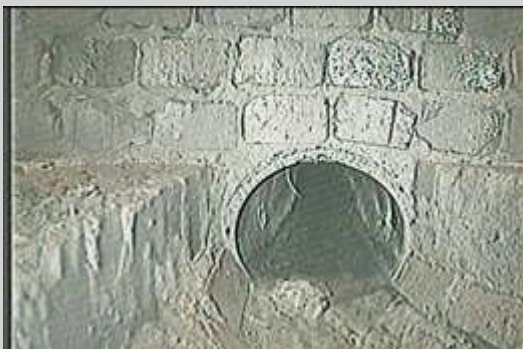
8 in. Circular Gravity Sewer Pipe In @ 9 O'Clock

Deposits: ☐ None ☐ Mud ☐ Sludge ☒ Debris ☒ Grease

Silt Depth: **0** (in.) Deposits Extent: **Light**
